# WATERBODY DATA FORM

Feature ID #: S6AME001

Stream/Waterbody Name (if known): WEST BRANCH PINE CREEK

Date: 6/25/08	Project Name & No.: Keystone XL-10623-007-803A	Milepost: 378.7
Investigators: 6A	State/County: SD/ MEADE	Quad Name: SQUAW BUTTES
Logbook No.: 2	Logbook Page No.: 10,11	Tract No.: ML-SD-ME-00150.000
		Picture No.: S6AME001_NE,S,SE

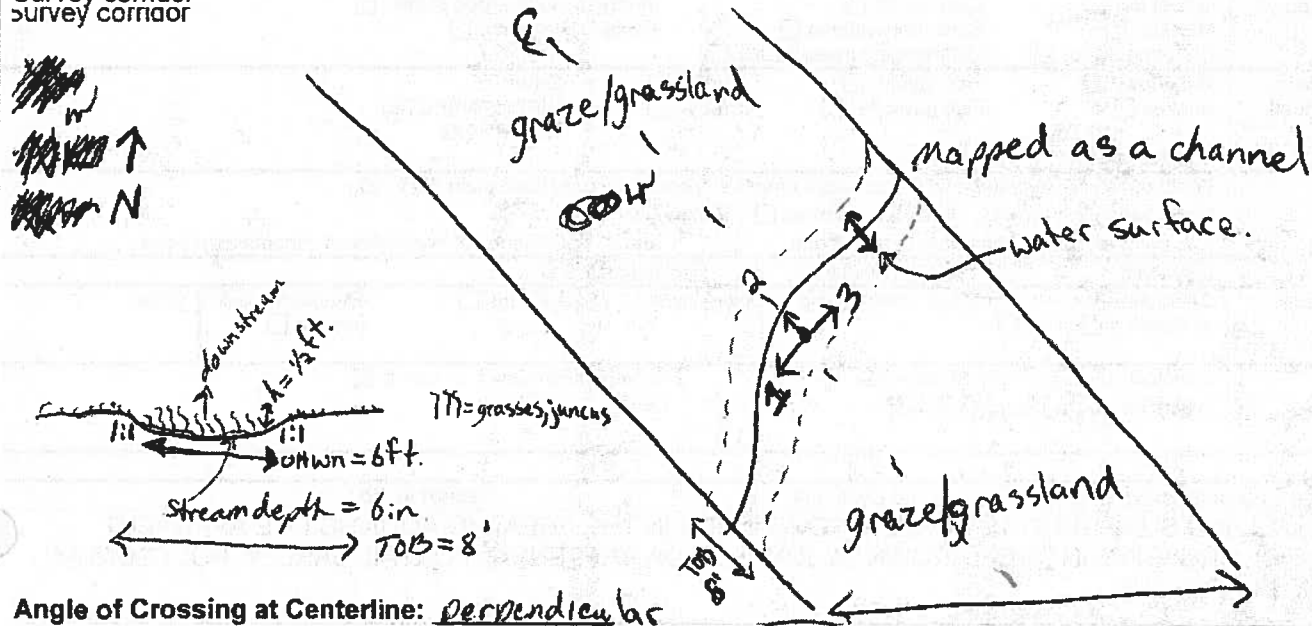
### Waterbody Sketch Plan

Describe Habitat Characteristics, Aquatic & Terrestrial Diversity:	Habitat ID No.:
-GRASS/ GRAZELAND SURROUND THE CREEK. SONG BIRDS IN THE AREA. NO AQUATIC LIFE APPARENT - CHANNEL @ CL CROSSING IS OVER GROWN W/ JUNCUS POA PRETENSIS, FOXTAIL BARLEY, POLYGONUM SPRINKLED THROUGHOUT.

Comments (e.g. pipeline crossing angle, construction constraints, erosion potential, existing disturbances, and meanders)
-DECHANNELIZED @ CL CROSSING, FAIRLY DRY. MAPPED AS A CHANNEL. -CATTLE HAVE WATER ACCESS
<b>STREAM QUALITY</b> High <input type="checkbox"/> Moderate <input checked="" type="checkbox"/> Low <input type="checkbox"/>
